## JOINT PHOTOGRAPHIC INTELLIGENCE BRIEF

Alleged Guided Missile Sit Near Bialystok, Poland None 168	BRIEF NC DATE LAT. LONG.	.: JB-4-59 : 17 March 1959 : 53 <sup>0</sup> 05'N to 53 <sup>0</sup> 20'N : 23 <sup>0</sup> 19'E to 23 <sup>0</sup> 47'E
	MAD DATA.			
25X1D	MAP DATA: AMS Series M508, Sheet S-54, 1:250,000 (U).			
	ATTACHMENT: Map showing rail spurs near Bialystok, Poland			
	REQUIREMENT: Follow-up study of preliminary work originally accomplished in response to requirement No. J-1-58.			
	REMARKS:			25X1D
25X1D	This brief discusses five rail spurs, covered by photography of located on rail lines between Bialystok, Poland and Volkovysk, USSR, and between Bialystok and Grodno, USSR (see attached map). Collateral has alled that two guided missile sites were constructed in this area prior to An analysis of the five rail spurs has been made to determine whether they are associated with the reported missile activity. It has been concluded from photographic analysis and additional collateral that these spurs service transloading sites, probably for military use.

PIC/JB-4/59

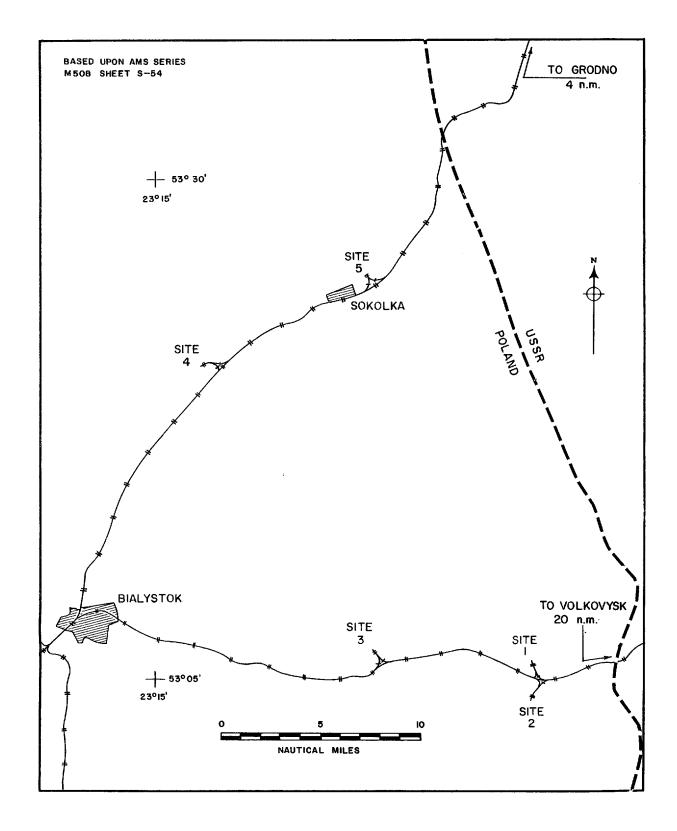
Attachment to PIC/JB-4/59

Three spurs (Sites 1, 2, and 3) leave the Bialystok/Volkovysk line. Sites 1 and 2 are located 3.7 nautical miles (nm) from the Soviet-Polish border, and Site 3 is 12.1 nm from the border. The other two spurs (Sites 4 and 5) leave DECLASS REVIEW by NGA/DOD

the Bialystok/Grodno line at points 16 and 7.2 nm, respectively, from the border. The two main lines and the spurs probably have both Soviet broad-gage and Polish standard-gage tracks. The five sites are also characterized by being located in isolated wooded areas.

Sites 1 and 2 have concrete side-loading platforms and are probably military equipment transloading stations. An adjacent railroad yard along the main line is associated with these stations. There are no visible security fences in the area. At Site 3, which is fenced, no loading platforms are present. However, on a hill several hundred feet distant secured excavations are underway for two clusters of four probable POL tanks each. A ditch is under construction from each of the two excavations to the fenced transloading site. Photographic interpretation and additional collateral indicate that this site is a POL transloading facility with provision for surplus POL storage.

Site 4 on the Bialystok/Grodno line has a concrete side-loading platform similar to those found at Sites 1 and 2, and it is also a probable military equipment transloading station. No railroad yard is associated with this station, nor is there any apparent security fence. Site 5 has the configuration of a turning wye extending into a wooded area, but resolution and obliquity of the photography precludes further interpretation.
